# Flood Investigation Report

*Portesham*  
*19<sup>th</sup> January 2019 Event*

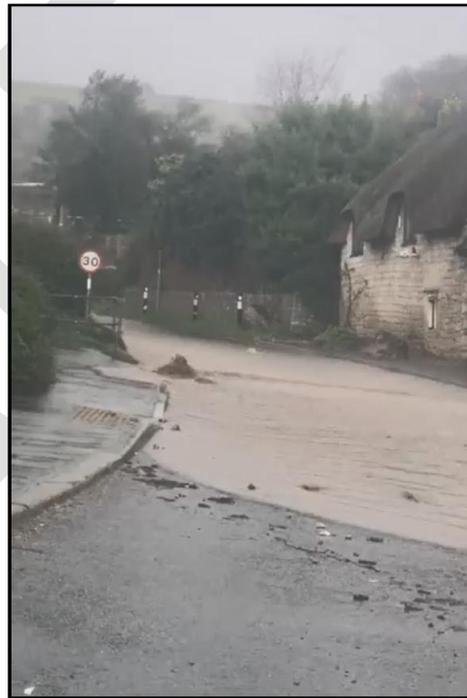
**Photo 1 – Front Street looking north towards Portesham Hill**

The highway drainage system was unable to cope with the volume and velocity of the flood water. Photo 1 shows the highway drain surcharging and flowing along Front Street. A portion of the flood water entered the watercourse that flows south on the western side of the carriageway. However, footage of the incident shows the watercourse overtopping back onto the road on the upstream side of several culverts.

The sluice gate, that offtakes the stream via a culvert under Front Street to the elevated eastern channel, was locked and in the shut position. Residents and members of the Parish Council were unable to open the gate to allow additional flows through this channel. Opening the sluice gate during the event could have reduced the flooding experienced in Front Street. Although the impact would have been limited given the restriction of the culverted section under the highway. However, it does identify the need to have a management plan in place to enable the sluice gate to be opened during high flows.

After the sluice gate, the western channel becomes elevated, with the bed of the stream almost level with the highway. The watercourse overtopped at this location, flowing back onto Front Street. One property flooded here due to obstructions within the channel.

Improving the maintenance of the watercourse would increase the capacity of the channel and reduce the risk of blockage, reducing the flood risk. Alterations to the channel to remove permanent blockage risks, such as low bridges, would also have a positive impact on flood risk upstream. However, the downstream effects would need consideration.

It is recognised that improved maintenance of Portesham stream is needed to reduce flood risk from future high rainfall / groundwater events, this is problematic as the responsibility is shared between a large number of parties. It is recommended that a community approach is implemented, in which responsibility for maintenance of the watercourse is shared between all members of the community, rather than just those with riparian ownership responsibilities.

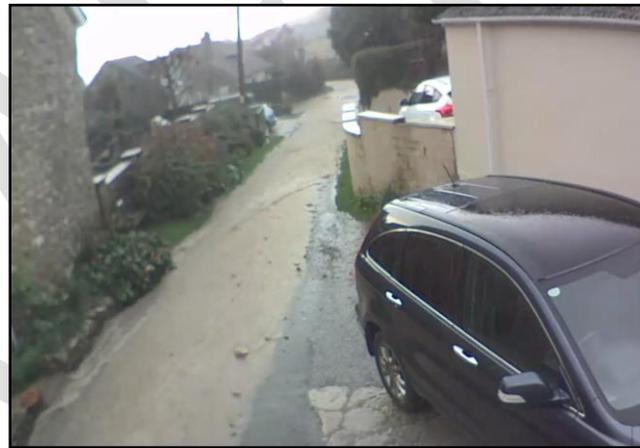
**Photo 2 – Rocky Lane looking west towards Front Street**

Overland flows from the surrounding hills were conveyed via a farm track and Right of Way (RoW), bringing with it a significant amount of silt and gravel. A soakaway was installed at the entrance to the RoW, however it was situated higher than the footpath.

During the flood event flows were unable to enter the system, although the soakaway would not have coped with the volume of surface water experienced during the event.

A section of Rocky Lane was recently tarmacked. While this has improved the surfacing of the Bridleway, it has unintentionally resulted in surface water run-off increasing in velocity. Residents have stated that the camber of the highway changed as a result, and now the bridleway channels surface water towards the properties on the southern side of the Lane. One property experienced internal flooding during the event. There are several small ditches and culverts that run along the southern edge of the bridleway that intercept springs along the track. However they are not designed to cope with an extreme rainfall event.

It is recommended that Natural Flood Management interventions are explored to divert/reduce the amount of overland flows from the surrounding hills that are conveyed onto Rocky Lane. Further investigation is needed into the current drainage arrangements installed by RoW. It is also recommended that property level resilience and/or resistance

measures are considered in properties at risk of flooding. Riparian owners are also advised to ensure that ditches and culverts are maintained and offer unobstructed flow.

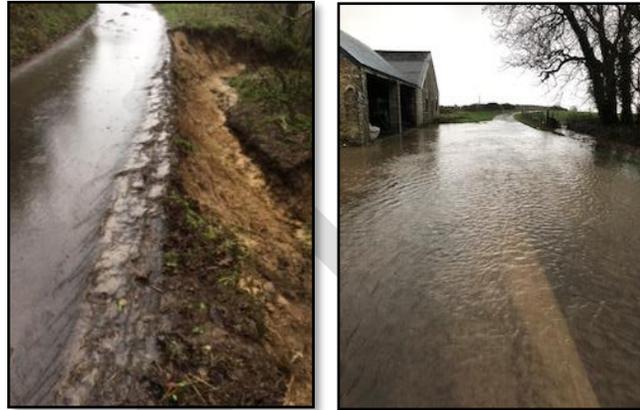
**Photo 3 – Bank collapse and flooding at Portesham Farm**

The extreme rainfall led to overland flows flooding the external buildings of Portesham Farm. The farm track then acted as a conduit for the flood water, this led to localised land slippage of the track. The mud and debris from the slippage mixed with the exceedance flows which resulted in the flooding of Winters Lane.

A portion of the surface water on Winters Lane discharged into a culvert along the back of properties in Winters Close. Most of the exceedance flows were conveyed onto Front Street, and towards Goose Hill. The mud and debris contributed to the highway gullies blocking along Front Street and the B3157 Coast Road.

It is recommended that the LLFA explore whether there are any Natural Flood Management interventions that could slow/divert the run off from the hills and reduce silt deposition. This could be in the form of sit traps at field boundaries or cross drains on farm tracks. This could help reduce the amount of silt that is entering the highway drainage system. There are several smaller ditches and culverts that run along both sides of the highway that intercept spring water along Winters Lane. These culverts would not have coped with the extreme rainfall, however some are currently blocked, resulting in spring water flowing across the highway in normal conditions. Although they did not contribute significantly to the flooding experienced, it is recommended that these culverts are repaired and maintained to enable the free flow of water. This will also decrease the risk of ice forming across the highway during the winter months.

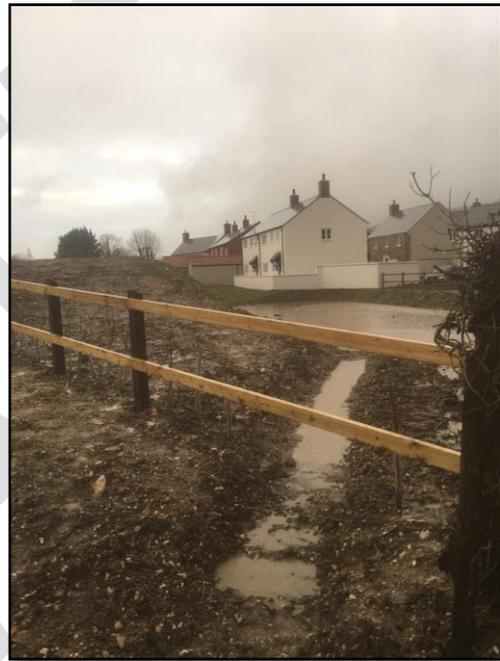
**Photo 3 - Cut through at  
Malthouse Meadows**

Previously this was a greenfield site with a history of flooding. During the 2012 flood event, the field flooded and a cut through was made in the redundant railway embankment to relieve the flood risk to the adjacent Village Hall. This cut through was accepted as part of the existing drainage characteristics of the site when the site was developed.

During the event, the culvert under the railway embankment coped with the additional flow, photos with photos showing show that it was at approximately 75% capacity. However, silt build up and obstructions in the watercourse downstream of the culvert caused flows to come out of bank, resulting in property flooding. To alleviate this, the weir on the upstream side of the culvert was lowered to allow more flow into the attenuation pond. This reduced the impact of the watercourse downstream coming out of bank but filled the attenuation pond more quickly. However, it did not overflow onto the highway on this occasion.

It is recommended that the watercourse is cleared of silt and obstructions to enable a free flow of water. Shortly after the event the watercourse downstream of the railway embankment was de-silted and obstructions removed, however this needs to continue in conjunction with the full length of the watercourse and this could form part of the wider Flood Action Group initiative. There is a Management and Maintenance Plan in place for the development site and the developer needs to ensure that the plan is followed and works carried out on a regular basis to clear the watercourse around the site. With regards to the weir, this has now been constructed in brick and has been set at the level agreed by the development's planning permission.

Given the concern about the culvert under the railway embankment, it is recommended that the LLFA register this as a critical structure.

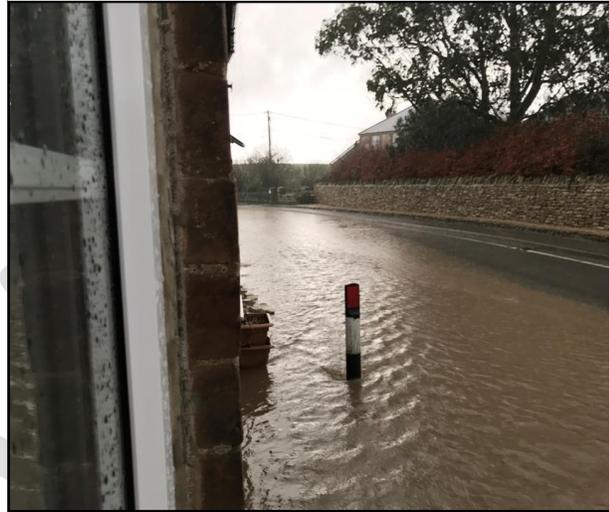
**Photo 4 -Goose Hill looking west towards Abbotsbury**

Goose Hill is at the lowest point of the Village at approximately 60m AoD. There are several properties that are situated along the southern side of the B3157 Coast Road. The properties here have low external thresholds so are susceptible to flooding.

During this event it was reported that six properties flooded internally. Surface water and fluvial flood water flowed through the village and onto the B3157. There is an open ditch system, upstream and behind the properties along Goose Hill. At the time of the event the ditch had capacity to take additional flows. However, due to the topography and camber of the road, the flood waters bypassed this system. This resulted in the floodwater collecting against the properties and across the road.

Residents raised concerns regarding the delay of the road closure. The impact of flooding on Goose Hill was greatly exacerbated by vehicles travelling along the B3157, due to 'bow-waves' pushing flood water above thresholds and into properties. They also raised concerns about the flood alleviation scheme at the Malthouse Development site.

It is recommended that residents explore the option of flood resistance and resilience measures to their properties, and that the LLFA also explore whether there are any funding opportunities available to assist residents with these measures.

The flooding experienced was exacerbated by the bow waves from vehicles driving through the flood waters. It is recommended that the LLFA, Dorset Police and DC Highways explore a road closure process for future flood events.

Given the prevailing flood risk from the surrounding area and the impact at Goose Hill, it is recommended that the LLFA and DC Highways explore a potential flood alleviation scheme to intercept flow paths. This could be achieved by directing water into the open ditch before the properties in Goose Hill. However further investigation is required with the relevant authorities to see whether this scheme would be feasible.

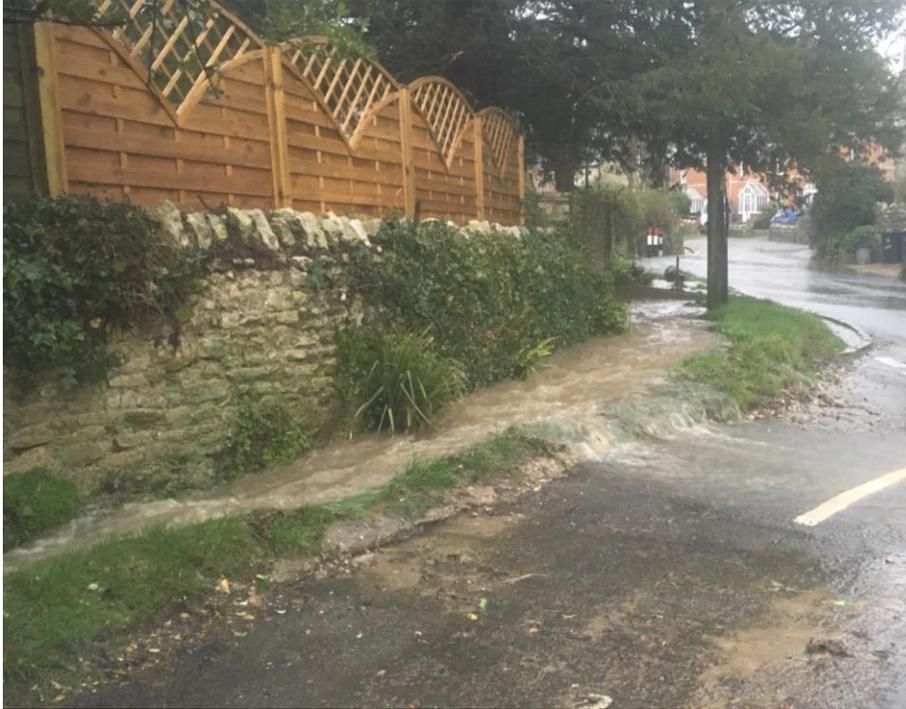
**Elevated western channel,  
looking north-east towards front  
Street**

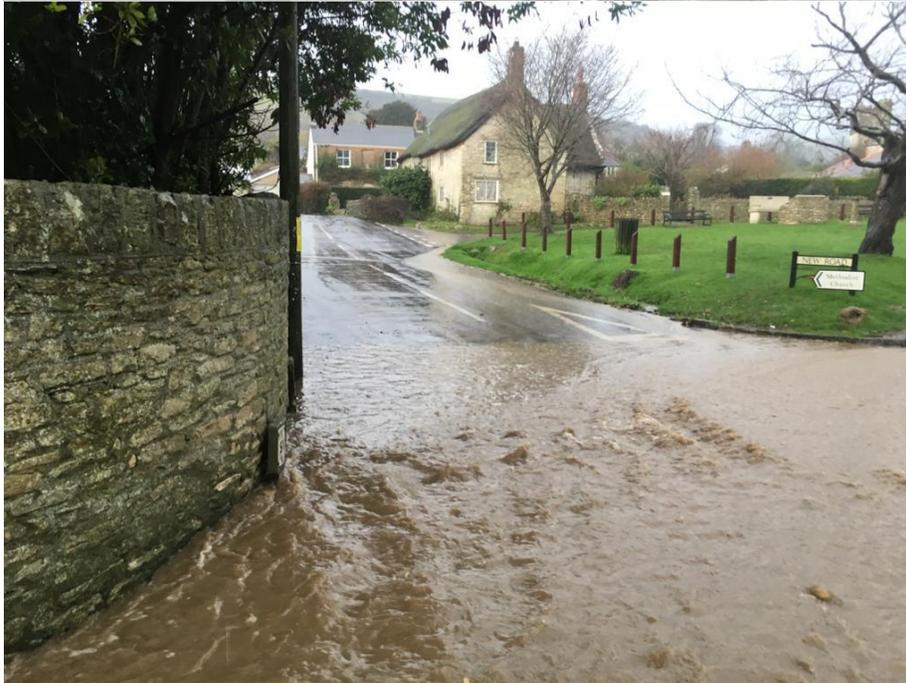
**Front Street, looking towards  
New Road**

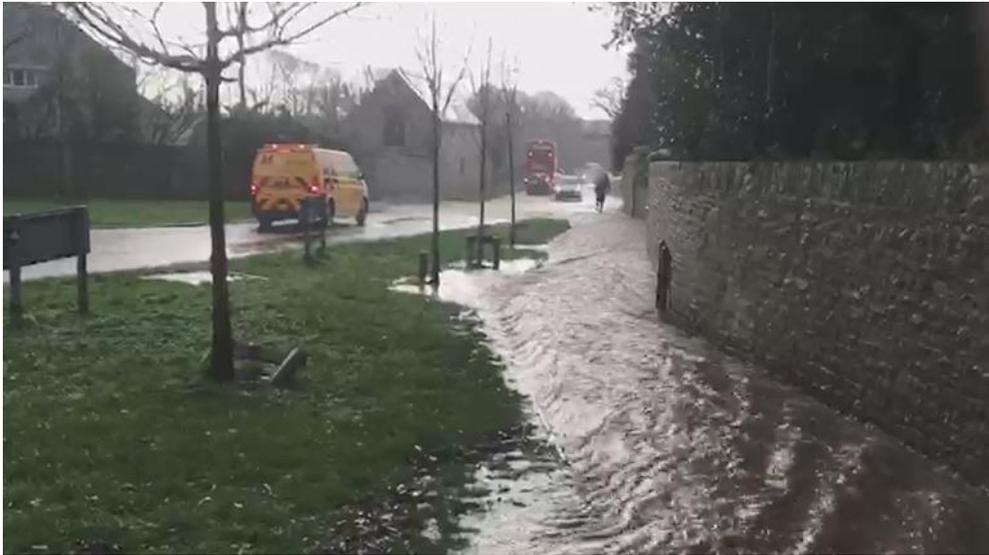
**Bottom of Front Street,  
looking west along the  
B3157 Coast Road**

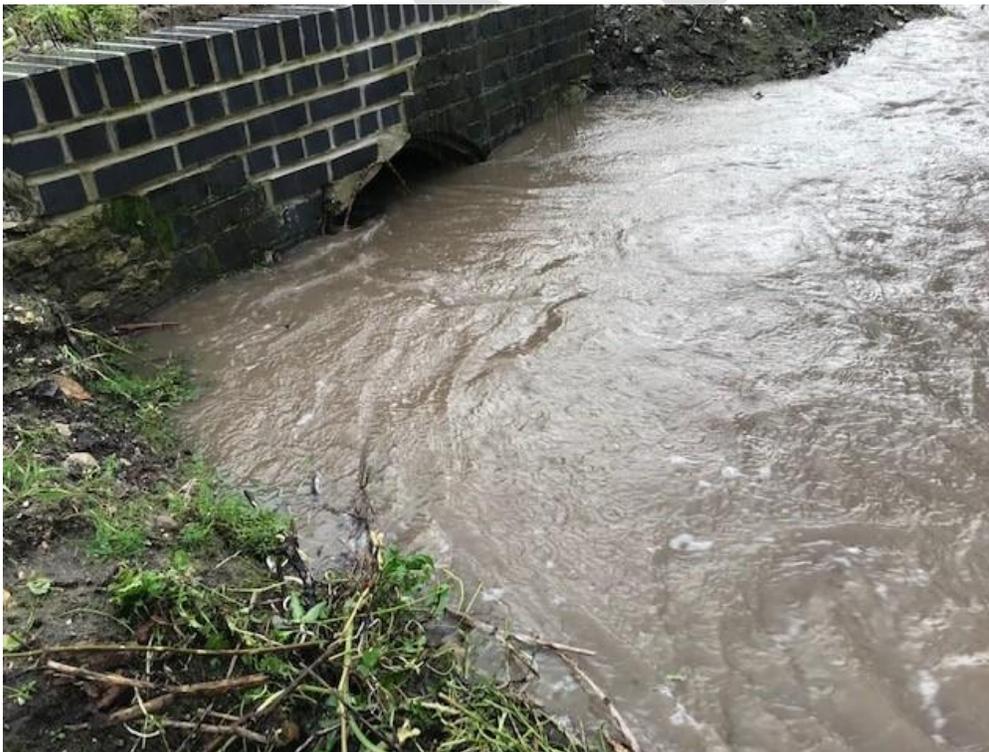
**Culvert under railway  
embankment,  
Malthouse Meadows**
