# Flood Investigation Report

*Portesham*  
*19<sup>th</sup> January 2019 Event*

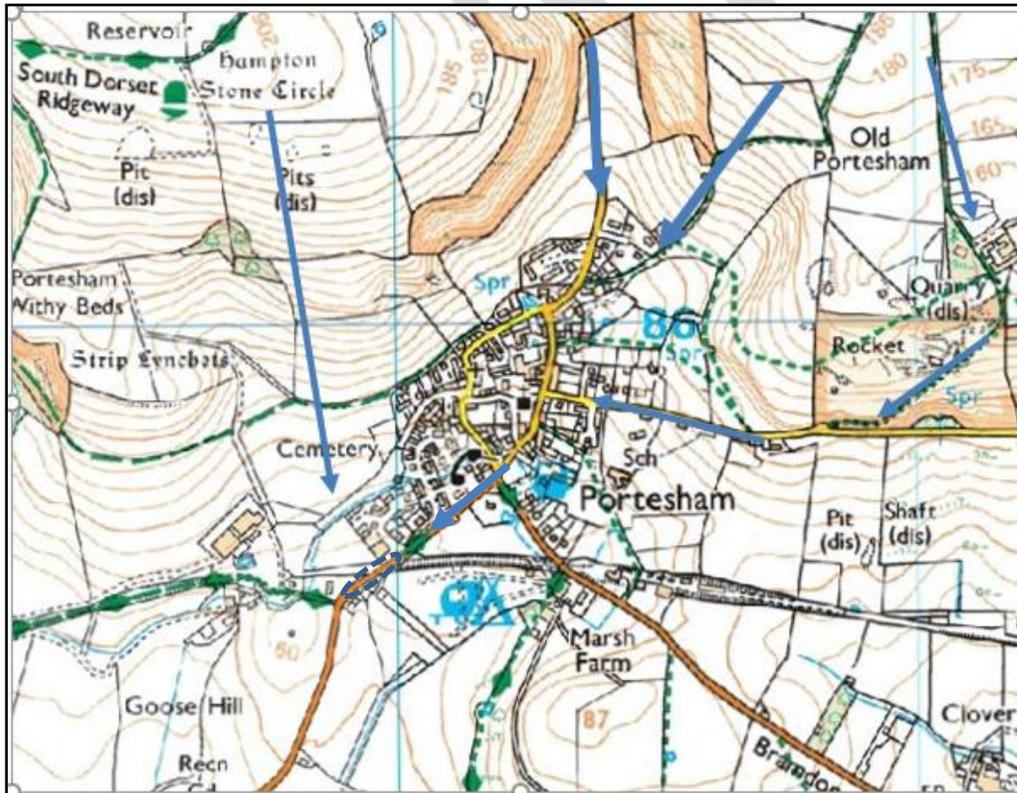
**Figure 3 - Overland flow paths**

During the afternoon of 19 January 2019, heavy rainfall fell on already saturated ground in the catchment of Portesham. Surface water from the steep hills to the north were conveyed via the Portesham Hill towards Portesham Village. The velocity and volume of water inundated the highway drainage system. A portion of the overland flows entered Portesham Stream in Front Street, however restrictions in the watercourse meant that flows came out of bank and back onto Front Street. Rocky Lane to the north east and Winters Lane to the east also experienced surface water flooding. These flows combined with the flood water of Front Street and conveyed onto the B3157 Coast Road. Traffic movement was significantly disrupted, and the road eventually closed for an extended period; flood depths of up to approximately 400mm on the highway were reported.

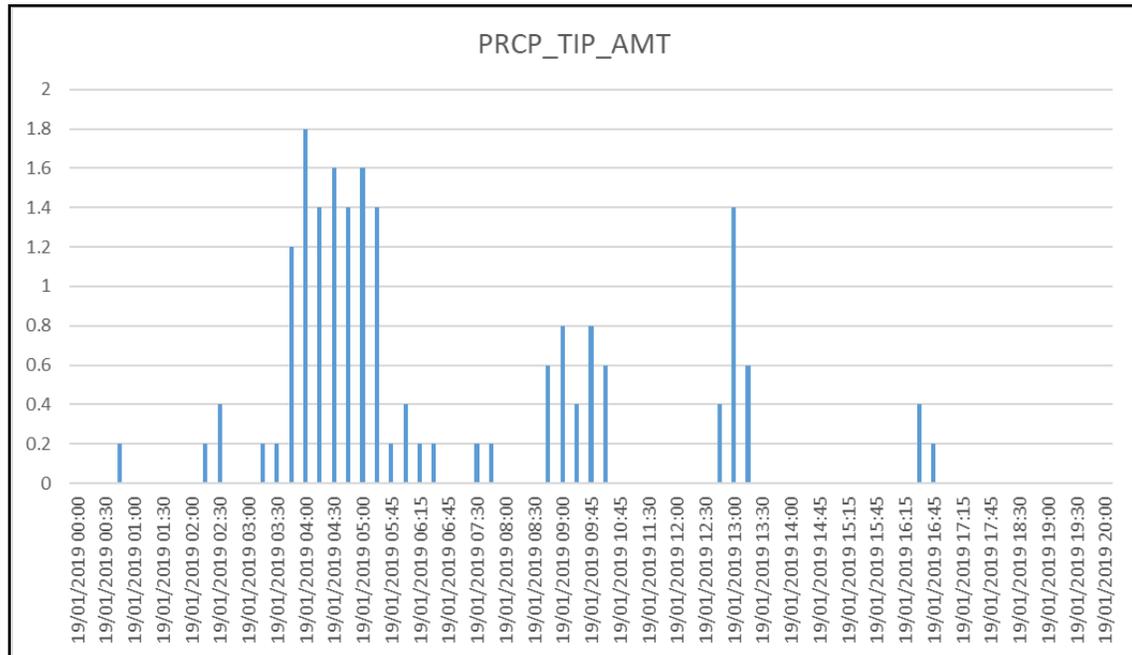
**Figure 4- Rainfall Data Friar Wadden**

the event during the afternoon. This would be explained by the change in the weather system's direction.

The two events earlier in the day would have meant that the ground was already saturated prior to the afternoon event, resulting in an increase of surface run-off from the surrounding catchment.

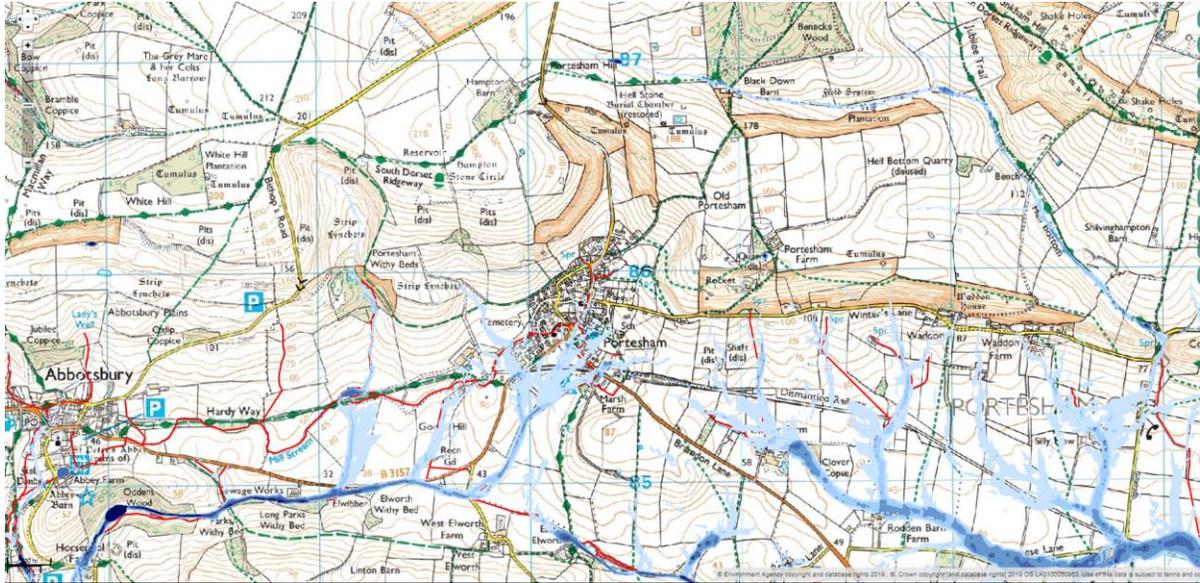
## Appendix 4 - Detailed Watercourse and Surface Water Mapping

(Surface water mapping showing a 1:100-year Flood Event)
